Adhered Masonry A Ticking Time Bomb?

Appian Consulting Engineers, PA

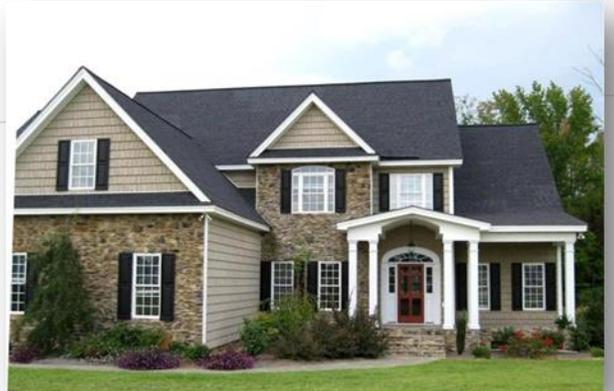
Few people would disagree that the house below looks better with the stone veneer than it would without it. But looks are deceiving in this case. Beneath a portion of the stone on this 4 year old house, there is significant framing decay.

In October of 2008, I was called to inspect a home that was experiencing a number of problems; the primary concern of the buyer being cupped floors on the first floor and a wet crawl space. Upon close examination of the home (see photo top right of home), at the front wall between the garage and front

porch, I found leaks inside the house on both the top and sides of the window frame, water stains on the sheetrock, soft drywall, swollen and cupping hardwood flooring below the window, and a high moisture content on the inside trim. On the outside of the house, there was no flashing or weep holes over the windows. Also, the stone window sill had been laid flat and; interestingly, I noticed that the stone veneer below the lower roof overhangs was uncharacteristically darker than the stone above the lower roof; an indication that roof runoff from the adjacent roofs was running down the face of the stone veneer and over the top of both lower windows. With no apparent provisions for handling the water, either on the surface or behind the stone, I suspected that the framing behind the stone veneer would have extensive decay and mold. As I mentioned previously, the sheet rock behind the wall was soft so water was definitely getting inside the wall.

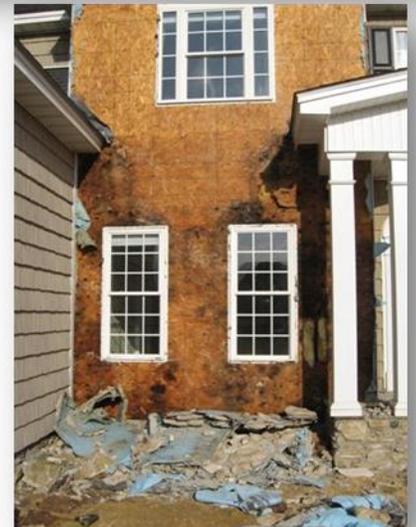
Once the stone veneer was removed, suspicions were confirmed. The stone veneer, with its substrate of cementitious parging and metal lath, had been applied directly over the Tyvek house wrap. The Tyvek, in turn, had been applied to the surface of the OSB wall sheathing. With the wall sheathing exposed, we could now see where water had migrated behind the stone veneer (see staining in photo at bottom right of page 1).

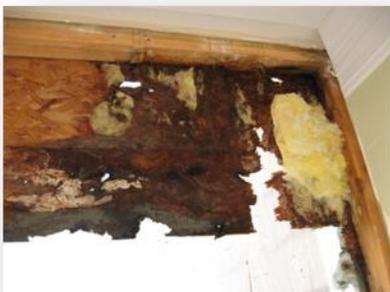
The leaks had decayed a significant portion of the wall sheathing (see photo of interior side of OSB wall sheathing, bottom left of page 1), studs, and adjacent floor joists on the front wall between the garage and porch.

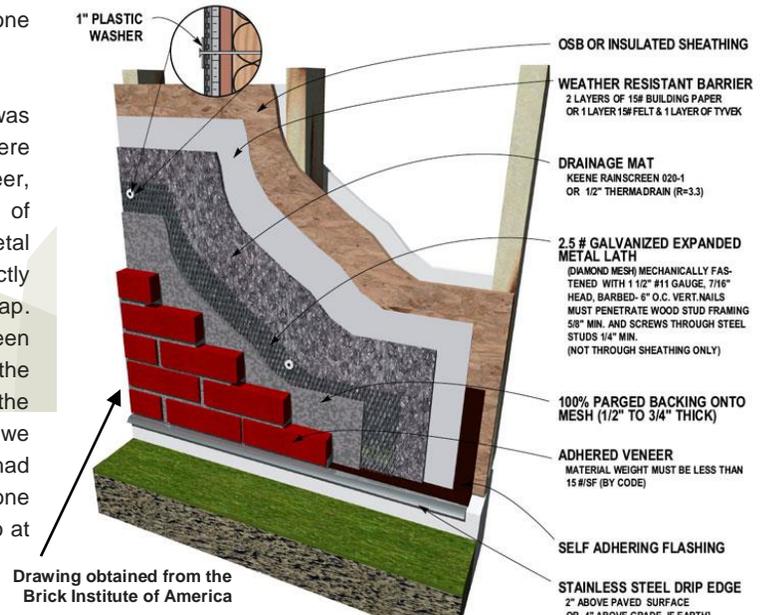
Drawing obtained from the Brick Institute of America

applied directly to framing in order to prevent moisture decay. Like the EIFS system, I expected that a drainage barrier was going to be needed behind the stone. For direction and guidance, the Masonry Advisory Council was contacted and asked if they had either specifications or standard details on adhered stone masonry. They did not but referred me to the Brick Institute of America's detail for adhered brick veneer (shown at bottom right of page 2).

They warned me that the BIA details did not go far enough in that they did not address window and door openings. They recommended that I incorporate steel lintels and/or flashing and weep holes above windows and doors.

With this information, I developed a set of specifications and details for the removal of damaged framing and provided detailed information for the "proper" replacement of adhered stone veneer.
