May 2020 Volume 11, Number 5 www.wasteadvantage.com

City of Rocky Mount's Tipping Floor Replacement: A Great Success

When the city of Rocky Mount, NC needed to replace their tipping floor due to excessive wear and tear, Leak & Associates stepped up to the challenge and installed a long-term solution.

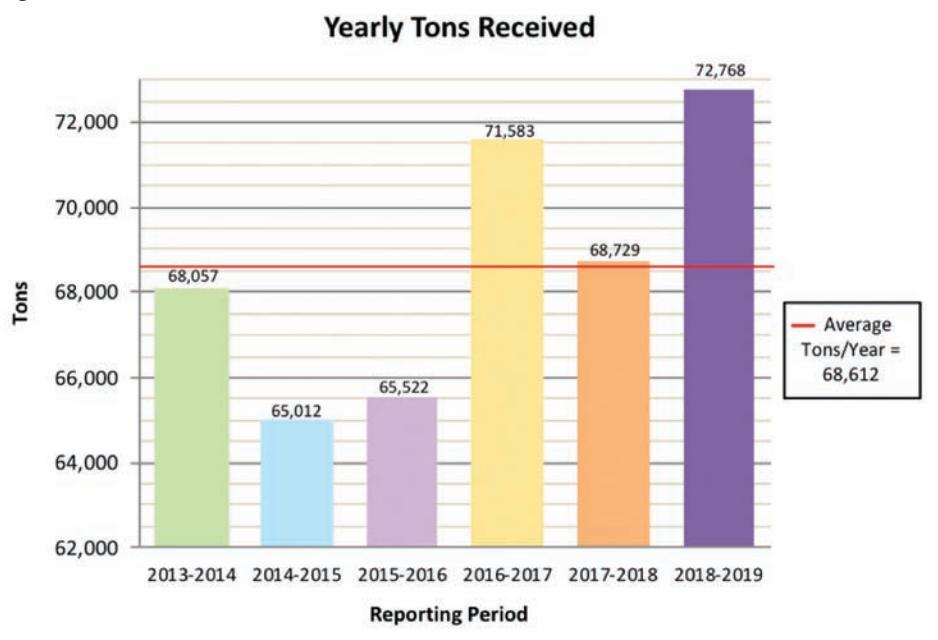
Figure 1:

The City of Rocky Mount receives municipal waste at this site in accordance with North Carolina Solid Waste Management Rules NCGS 130A. The facility does not accept hazardous waste, yard trash, liquid wastes, regulated medical waste, sharps not properly packaged, regulated asbestos containing material and wastes banned from disposal. The waste collected at this transfer facility is transported offsite to a regional sanitary landfill facility. The City does not use chemicals for washing the concrete floor. The facility is regularly inspected by the North Carolina Department of Environmental Quality (NCDEQ) Division of Waste Management Solid Waste Section. The facility operates five days/week for 52 weeks/year, with a total of 260 days/year in operation. From annual reports submitted to NCDEQ Solid Waste Section for reporting years 2013 to 2018, Figures 1 and 2 show the amount of solid waste received.¹

SOLID WASTE RECEIVED ¹ :	
Tons/year (avg)	68,612
Peak Tons/year in reporting period:	72,768
Tons/quarter (avg):	17,082
Tons/day (avg):	264

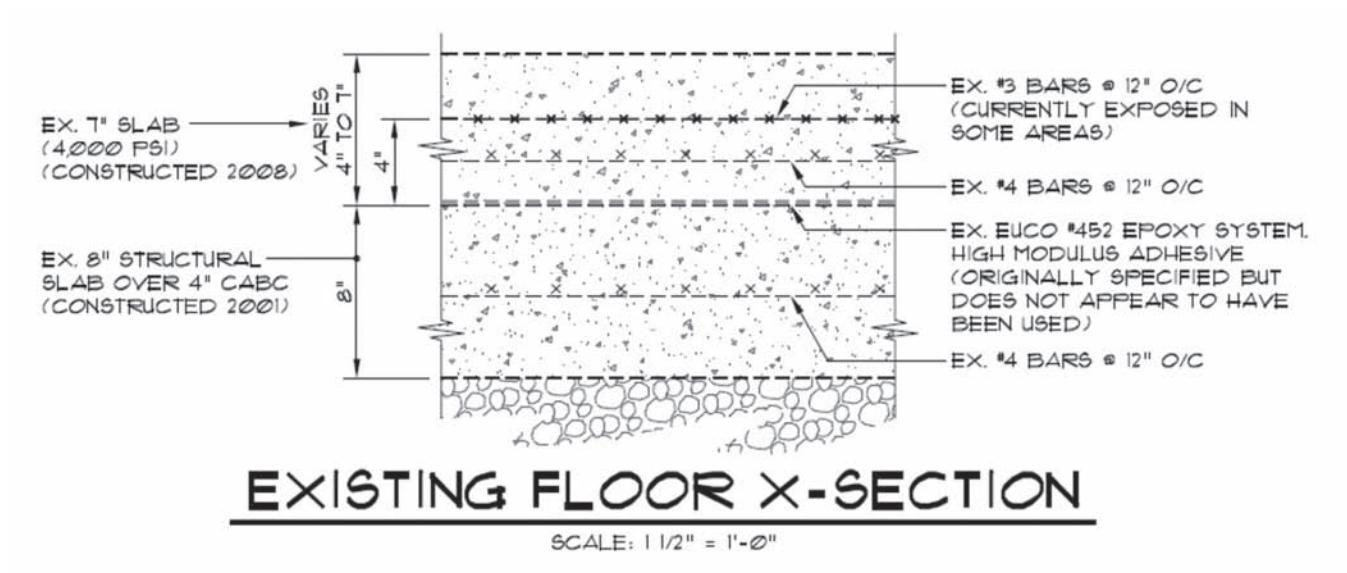
Figure 3: Existing Floor Section obtained from original construction plans and confirmed with coring.

The original base concrete was installed in 2001, with an additional top concrete slab placed in 2008. The reinforced top slab was to be bonded to the existing substrate slab with epoxy adhesive. In spring of 2008, the bonded 7" slab was installed on top of the underlying 8" structural slab, at an approximate cost of \$88,000, or \$16/sf (see Figure 3, page 69).

In 2012, the City began to notice that the floor showed significant signs of wear after just four years of use. Large areas of the top slab had eroded 3" in depth, so that that reinforcing steel was exposed and, in some places, protruding dangerously. Almost 25 percent of the floor became severely eroded so the City installed an asphalt patch for temporary repair. The push wall also needed repairs, as the structural attachments had pushed through the wall leaving holes.

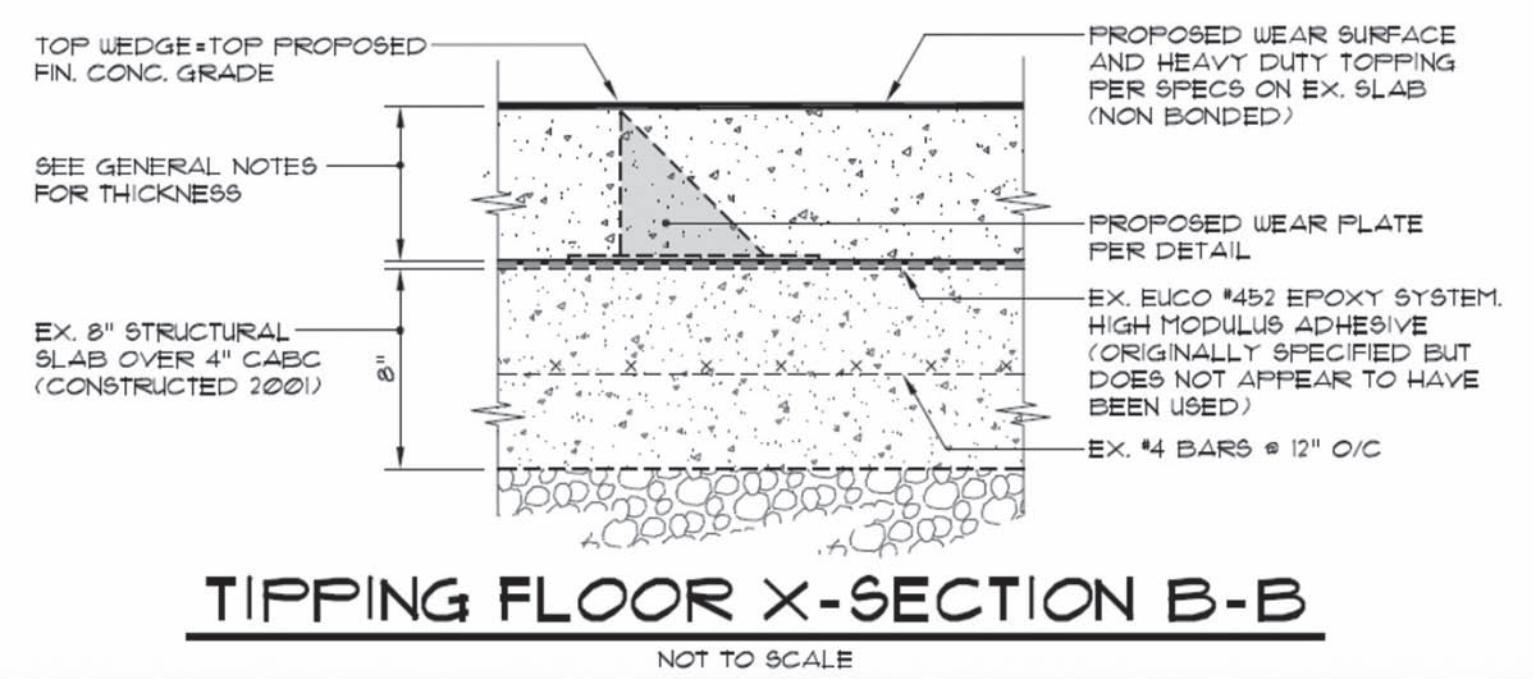
Figure 4: The typical floor cross section shows the proposed floor section used for bidding, though it was revised during construction.

Appian prepared a bid package and plans to remove and replace the existing 7-inch solid waste tipping floor and install a 6-inch wear course. The bid package was structured to enable bidders to provide an alternate design/build method or proprietary concrete slab that would provide adequate wear resistance with 10 to 15 years longevity. Figure 4, page 70, shows the proposed floor section for bidding, though it was revised during construction.

• Design for constructing a "sacrificial" concrete slab on top of the existing slab. The concrete for the new topping slab was optimized to have low shrinkage and curl and high abrasion resistance by the incorporation of specialty chemical admixtures, and optimizing cementitious materials and aggregate gradation. Additionally, the slab was reinforced, jointed and detailed to minimize cracking and wear.

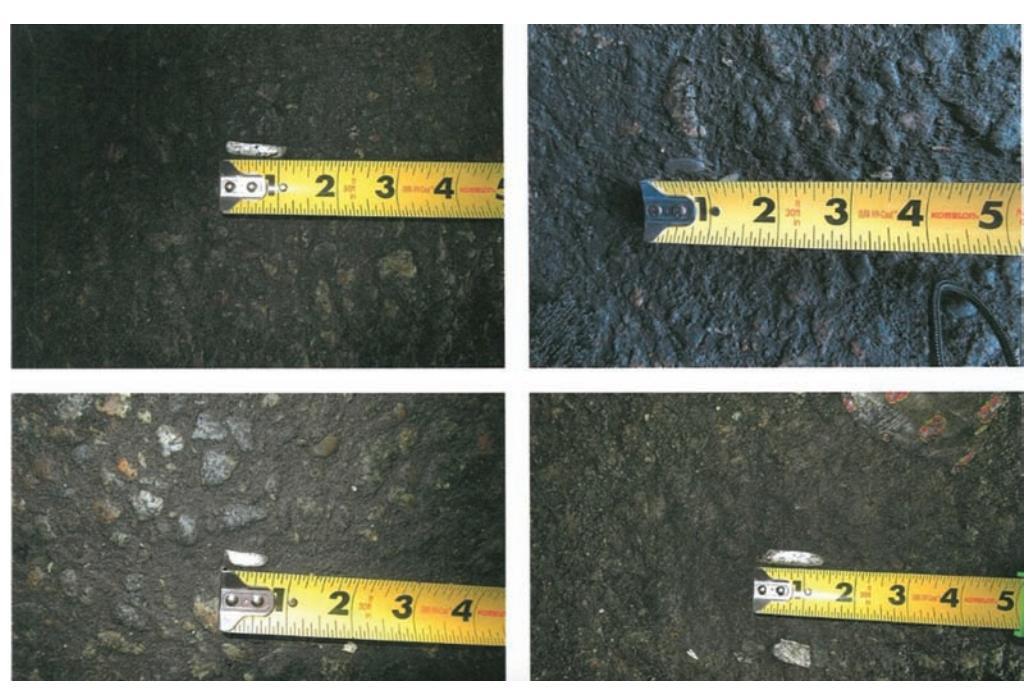
Figure 8: Measurements obtained 5 years after construction indicate that the deterioration of the new sacrificial floor (6" to 9" concrete slab) was less than 1-inch at the four wear plates. Figures courtesy of Appian Consulting Engineers.

Appian obtained detailed measurements of the wear plates and determined that there was minimal deterioration of the sacrificial wear slab over the past five years (see Figure 8). The wear plates indicate that the average deterioration of the new sacrificial floor (6" to 9" concrete slab) was less than 1 inch in the past five years. At the current rate, the projected life expectancy is more than 20 years without the need to replace the floor. If repairs are needed in the future, the floor is designed in such a manner that only the required sections need be replaced, not the entire floor—saving significant expense.
